Manhole Inspection Summary

Manhole # S43A2_027MH

Location Address: **928 E. Patapsco Ave.**

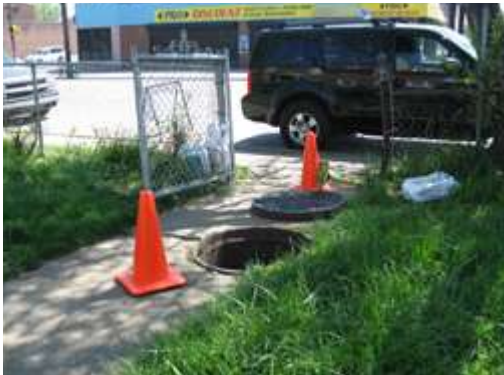
Location View

928 E. Patapsco Ave.

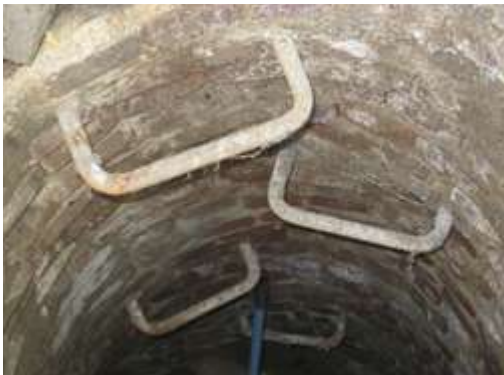
Steps Count: **4** Missing: **0** ☐ Corroded

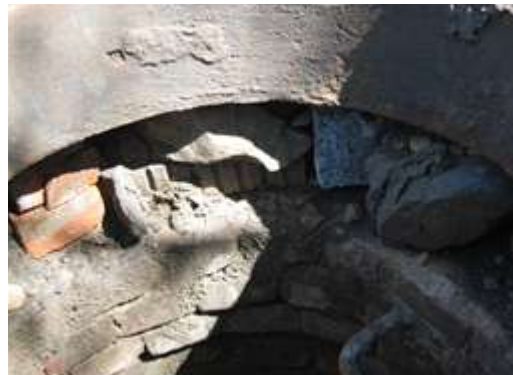
Defect 1

Condition: ☐ Sound ☐ Cracked ☐ Root Intrusion ☒ **Loose Brick** ☐ Deteriorated

Infiltration: ☐ None ☒ **Joint** ☐ Cracks ☒ **Mortar** ☐ Roots ☐ Wall

Loose bricks

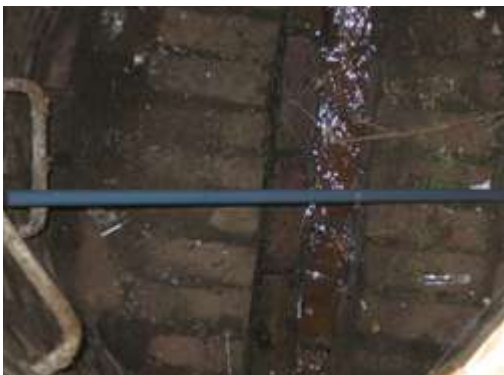
Defect 2

Broomstick

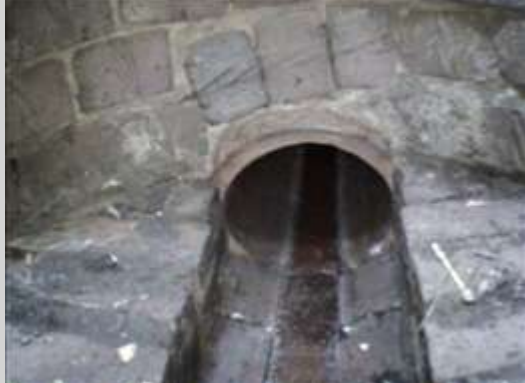
12 O'Clock Outflow

8 in. Circular Gravity Sewer
Pipe Out @ 12 O'Clock

Pipe Height: **8.4** (in.) Rod and Bar (Angled)
Pipe Material: **Clay** ☐ Pipe Lined
Invert Depth: **8.82** (ft.) Flow Characteristics: **Fast**
Deposits: ☒ None ☐ Mud ☐ Sludge ☐ Debris ☐ Grease
Silt Depth: (in.) Deposits Extent:
Infiltration: **None** Pipe Seal Cond: **Sound**

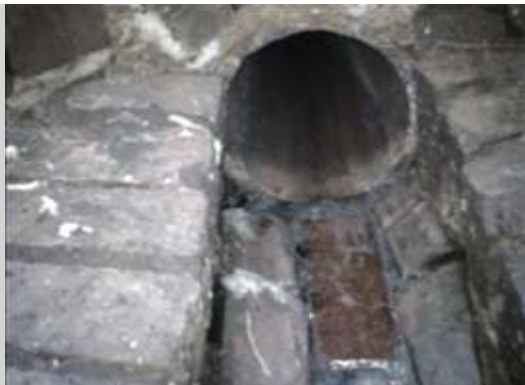
6 O'Clock Inflow

8 in. Circular Gravity Sewer
Pipe In @ 6 O'Clock

Pipe Height: **8.4** (in.) Rod and Bar (Angled)
Pipe Material: **Clay** ☐ Pipe Lined
Invert Depth: **8.53** (ft.) Flow Characteristics: **Fast**
Deposits: ☒ None ☐ Mud ☐ Sludge ☐ Debris ☐ Grease
Silt Depth: (in.) Deposits Extent:
Infiltration: **None** Pipe Seal Cond: **Sound**
